October 16, 2018

Mr. Robert M. Belmore, ICMA-CM  
City Manager  
City of Somersworth, NH  
One Government Way  
Somersworth, NH 03878

RE: **Fire Service Deployment Analysis - Management Letter**

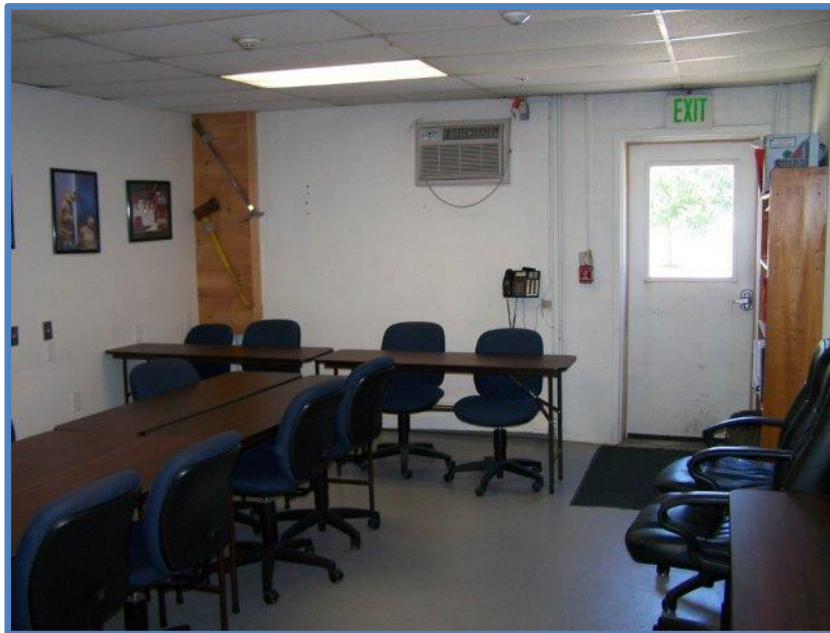
**Figure 8 - Inadequate training and meeting space.**

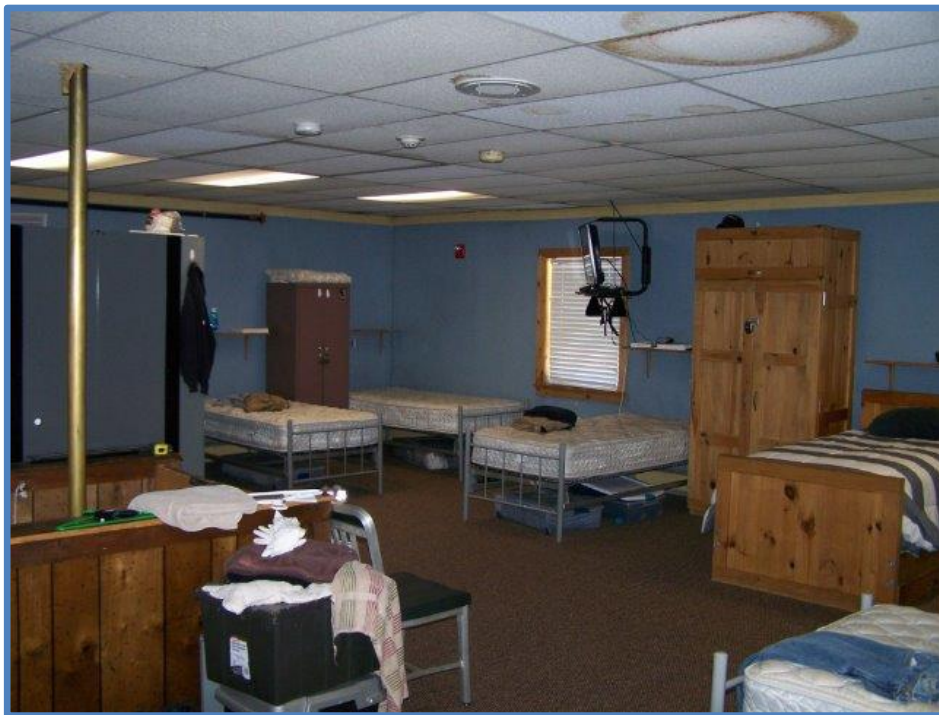
**Figure 9 – Common Dorm Area – This area does not meet the industry standard and prevents male/female separation. Roof leaks are evident in this photo.**

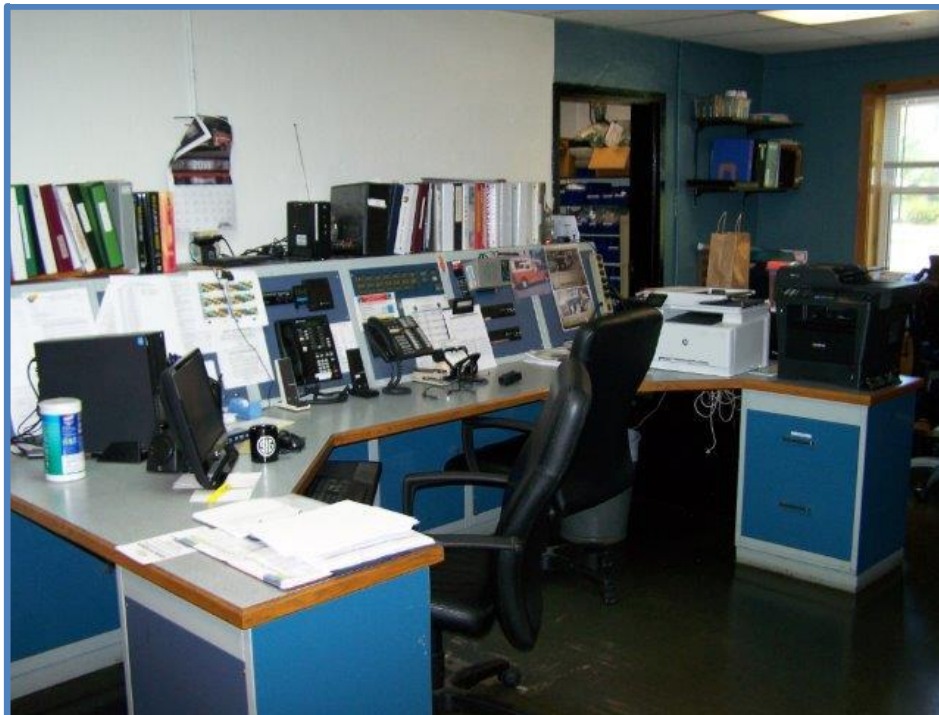
**Figure 10 - The dispatch area doubles as office space for all personnel other than the Fire Chief.**

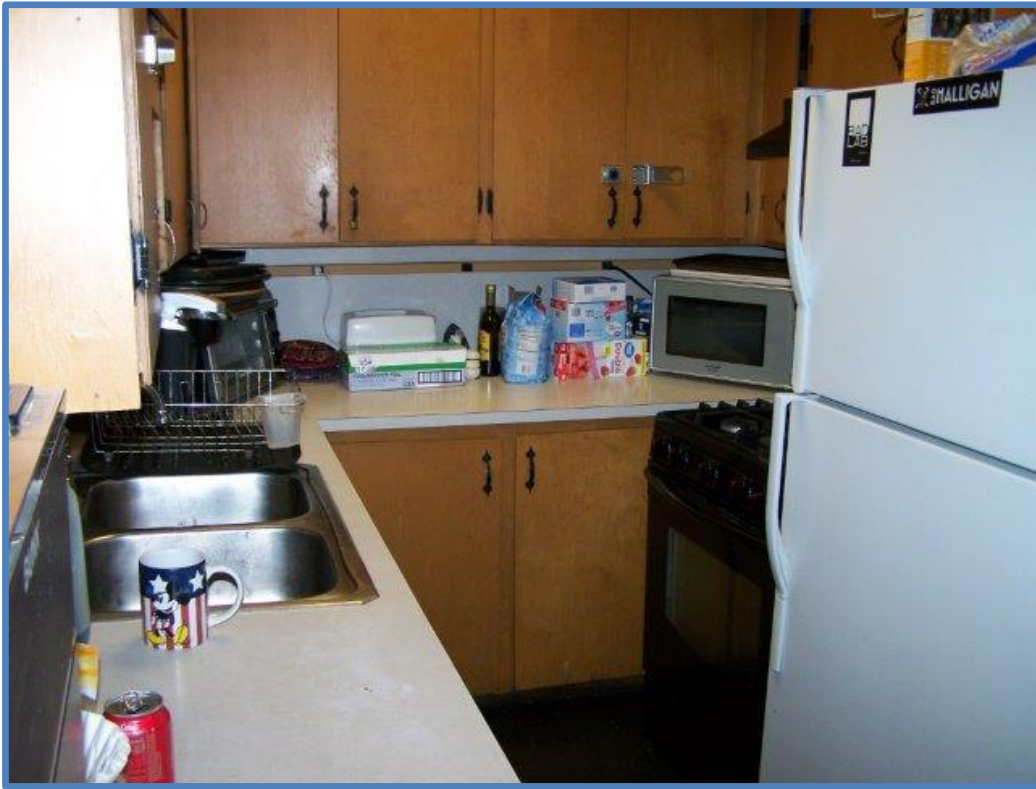
**Figure 12 - Kitchen space is inadequate for the on-duty shift and lacks sufficient space for a staffed fire service facility.**
