October 16, 2018

Mr. Robert M. Belmore, ICMA-CM  
City Manager  
City of Somersworth, NH  
One Government Way  
Somersworth, NH 03878

RE: **Fire Service Deployment Analysis - Management Letter**

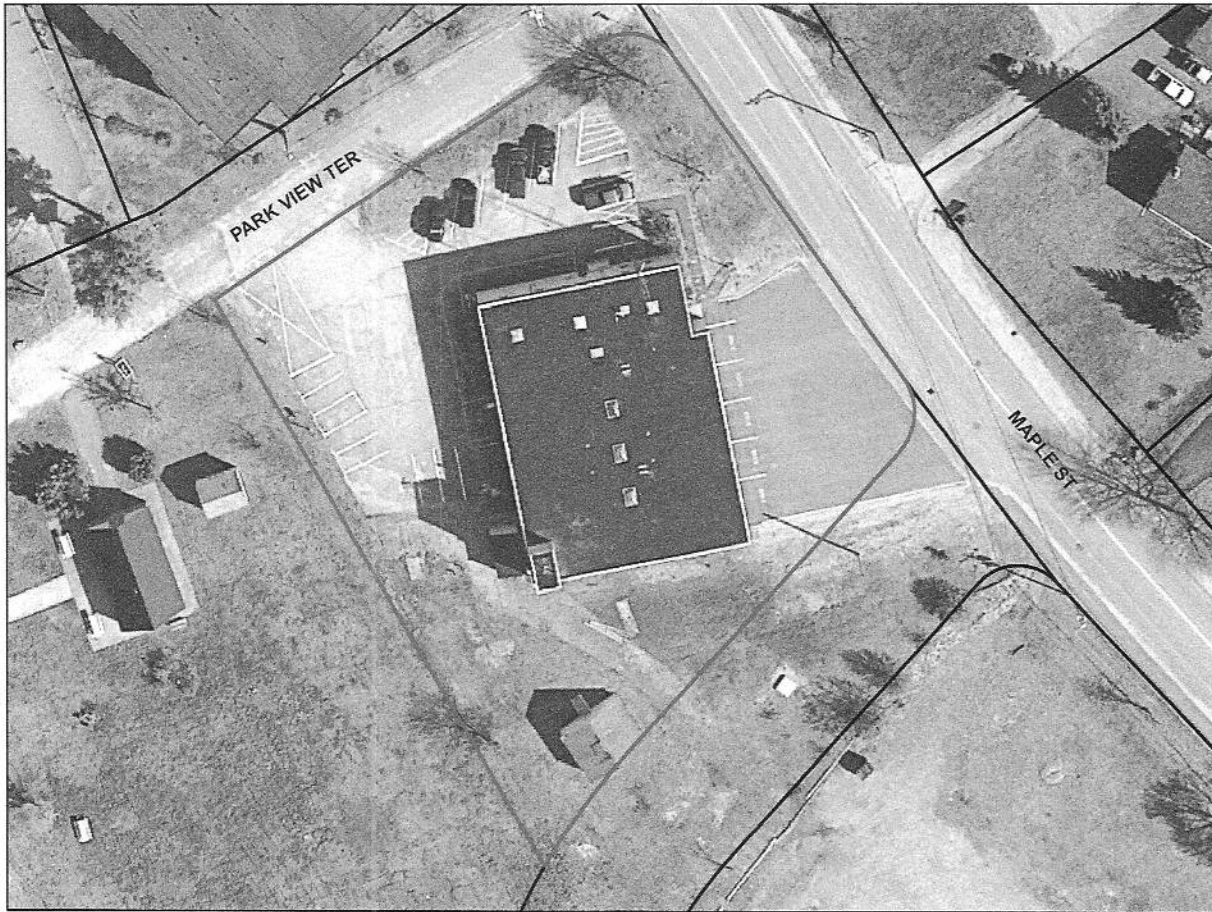
The Somersworth Fire Department was constructed in 1976 as a seven bay, single-story building with a two story administrative and living quarters building directly attached to it. The structure of the building has remained unchanged with only minor upgrades in interior finishes and safety systems over the past four decades.

The entire structure has a gross square footage (GSF) of 10,296. The first floor of the facility occupies 8,268 GSF, and 2,028 GSF on the second level. The building construction consists of load bearing masonry walls, with a bowtie steel truss framed flat roof.
